# REINFORCED EARTH TECHNOLOGY

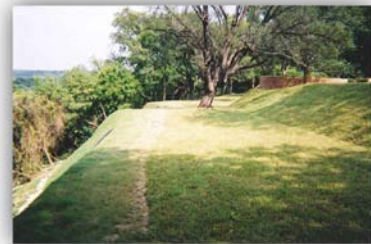
The scope of the design and remediation consisted of: stabilizing the support soil mass employing reinforced earth techniques; installing a “Geo-Web” containment structure at the base of the new reinforced soil mass; installing “composite drainage systems” along the face of the exposed soil slope to collect and discharge “free water”; and place grass seed along the slope face and secure a temporary erosion control mat to allow “seeding” to germinate.

Upon completing soil mass stabilization activities, the desired building structures were designed to bear directly over the new supporting soil mass – without the use of sub-surface pier supports.
